2005 Annual Inspection and Radiological Survey for the Piqua, Ohio, Decommissioned Reactor Site

Summary

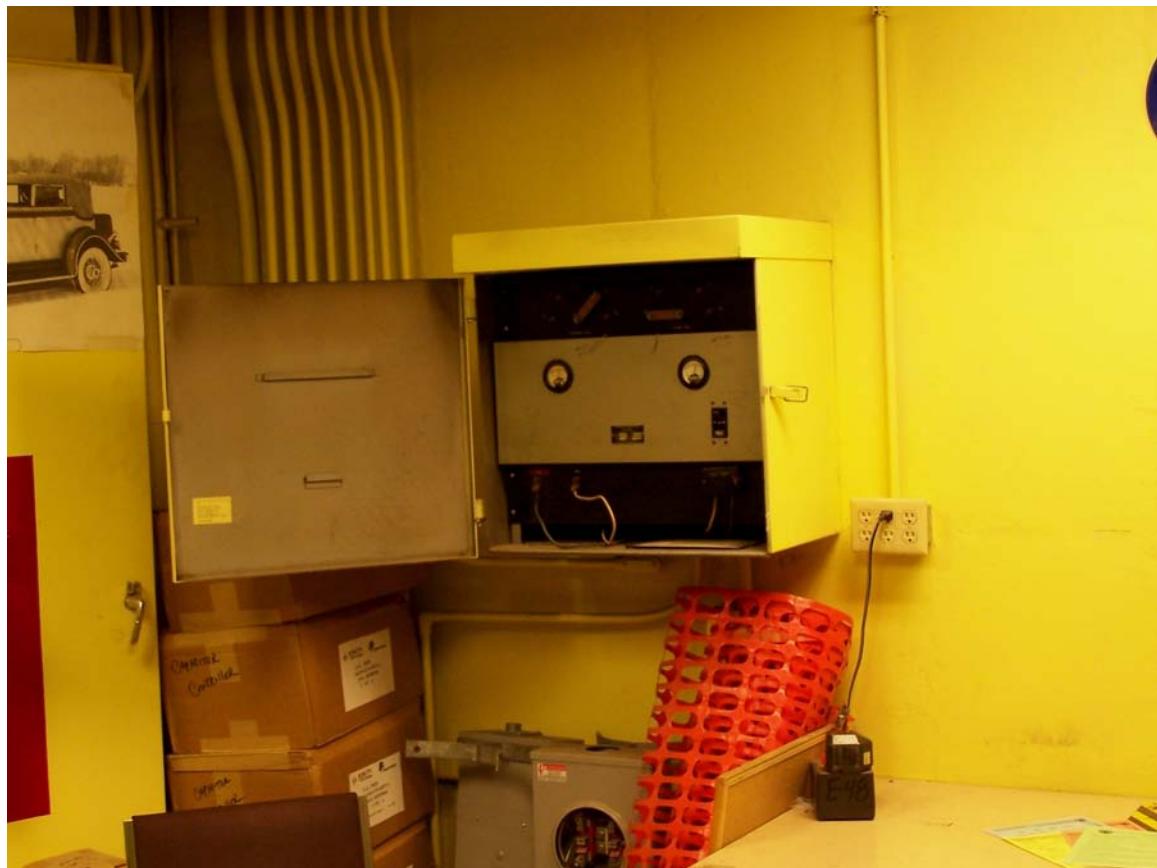
The system consists of 10 carbon (graphite) electrodes, buried radially approximately 10 to 20 feet from the building foundation, and a rectifier unit that provides DC current. The rectifier unit is mounted in the break room south of and outside the airlock on the 100-foot level (PL-1). Each carbon electrode is 3 inches in diameter and 60 inches long. The electrodes are connected to the rectifier unit by a header cable; splices are protected in flush-mounted boxes. A structure contact point for monitoring potential can be found on the shell associated with each electrode; some of the contact points also have cables remaining from an abandoned zinc anode protection system. The system also includes reference electrodes and test holes.

PIQ 4/2005. PL-1. Cathodic protection system rectifier.

1. Cathodic protection system is due for an inspection by a qualified service provider (page 2).

Recommendation: Mr. Sommer (PPS Director) has received notification that the system is due for inspection and he intends to request budget for that purpose. DOE will request a copy of the inspection results.

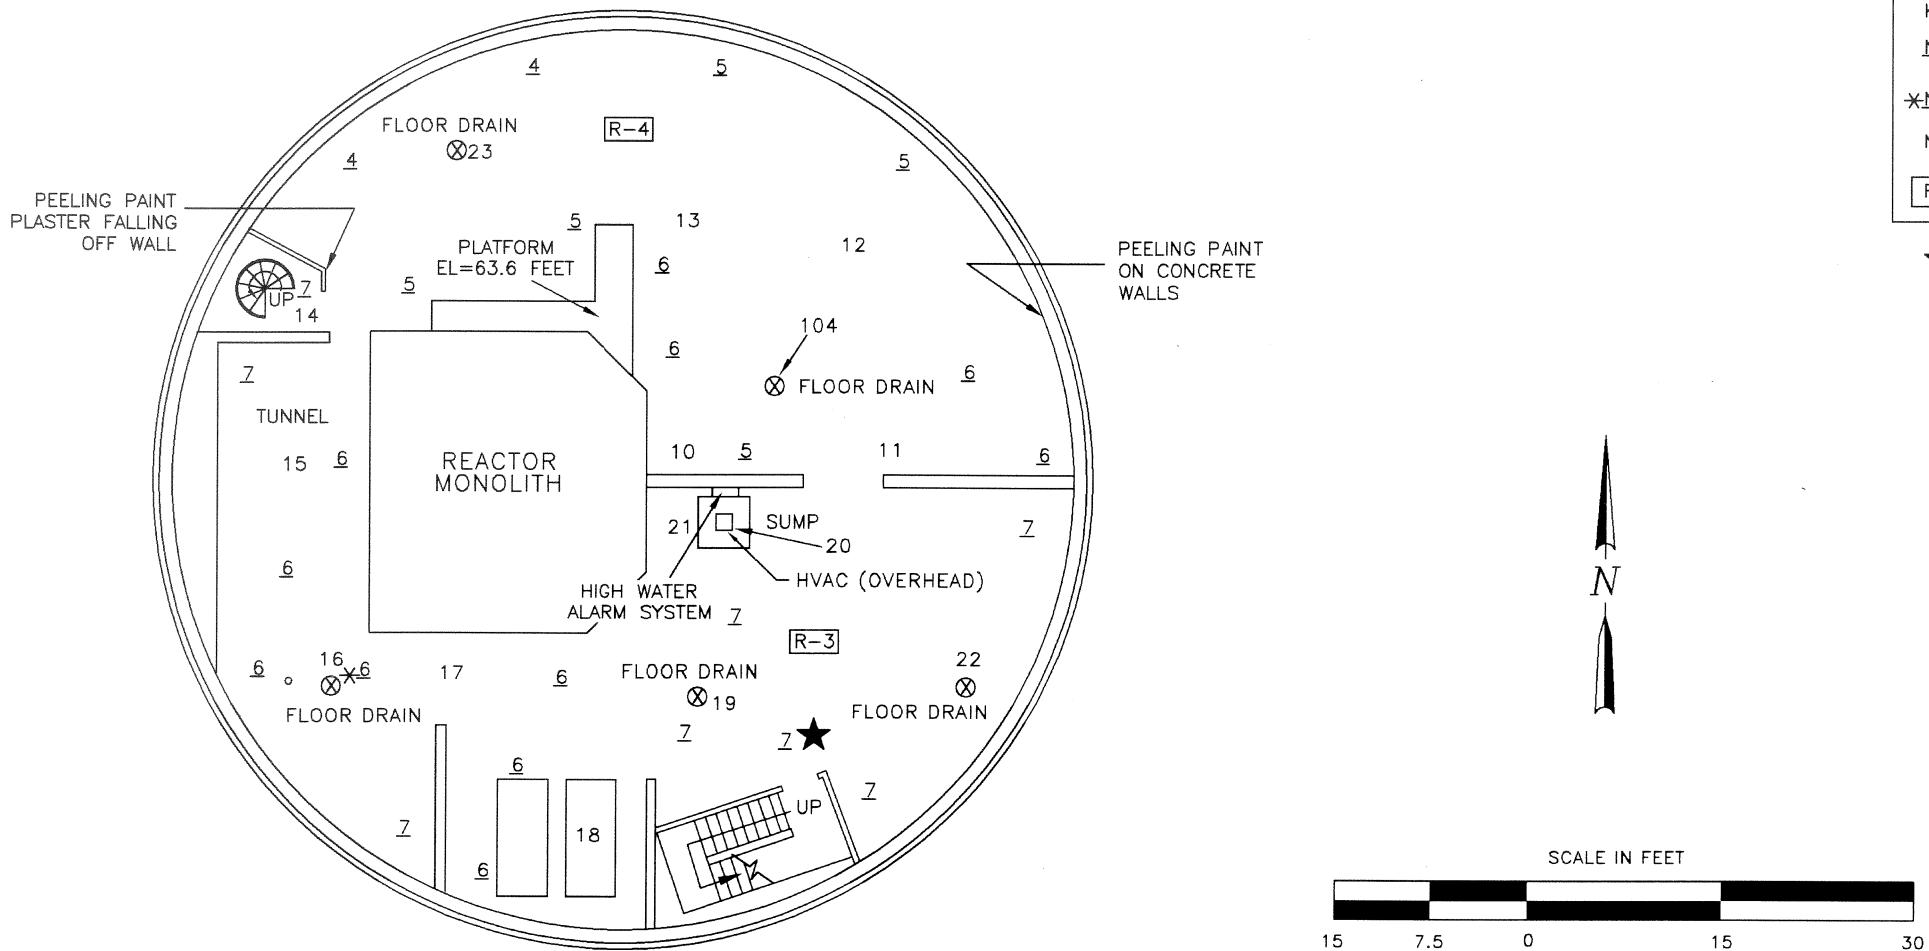
PLAN - 56 FOOT LEVEL

Table 2 presents direct surface and removable activity results. No removable contamination was found at any of the 111 sampling points. Direct surface measurement results indicate the floor drain at the lowest level of the containment building exhibited a direct beta activity of 3,310 disintegrations per minute per 100 square centimeters. The smear from this location indicated that no removable activity is present. This result is consistent with previous surveys. All other readings were below the minimum detectable activity (MDA) level.

Containment	56 ft.	16	<MDA	3,310	<MDA	<MDA	In drain
Containment	56 ft.	17	<MDA	<MDA	<MDA	<MDA	Floor
Containment	56 ft.	18	<MDA	<MDA	<MDA	<MDA	On pedestal
Containment	56 ft.	19	<MDA	<MDA	<MDA	<MDA	On drain
Containment	56 ft.	20	<MDA	<MDA	<MDA	<MDA	On sump grating
Containment	56 ft.	21	<MDA	<MDA	<MDA	<MDA	On HVAC unit
Containment	56 ft.	22	<MDA	<MDA	<MDA	<MDA	On drain
Containment	56 ft.	23	<MDA	<MDA	<MDA	<MDA	On drain
Containment	79 ft.	24	<MDA	<MDA	<MDA	<MDA	Floor
Containment	79 ft.	25	<MDA	<MDA	<MDA	<MDA	Floor
Containment	79 ft.	26	<MDA	<MDA	<MDA	<MDA	Floor
Containment	79 ft.	27	<MDA	<MDA	<MDA	<MDA	Floor
Containment	83 ft.	28	<MDA	<MDA	<MDA	<MDA	On top of HVAC duct
Containment	83 ft.	29	<MDA	<MDA	<MDA	<MDA	Grating on platform
Containment	83 ft.	30	<MDA	<MDA	<MDA	<MDA	Pipe adjacent to plenum
Containment	83 ft.	31	<MDA	<MDA	<MDA	<MDA	In duct
Containment	83 ft.	32	<MDA	<MDA	<MDA	<MDA	Floor grating
Containment	83 ft.	33	<MDA	<MDA	<MDA	<MDA	Pump pedestal
